BUREAU OF SHIPS GROUP TECHNICAL INSPECTION REPORT

OPERATION CROSSROADS. U.S.S. INDEPENDENCE (CVL22)

TEST ABLE

VOLUME 1 OF 4 [U].

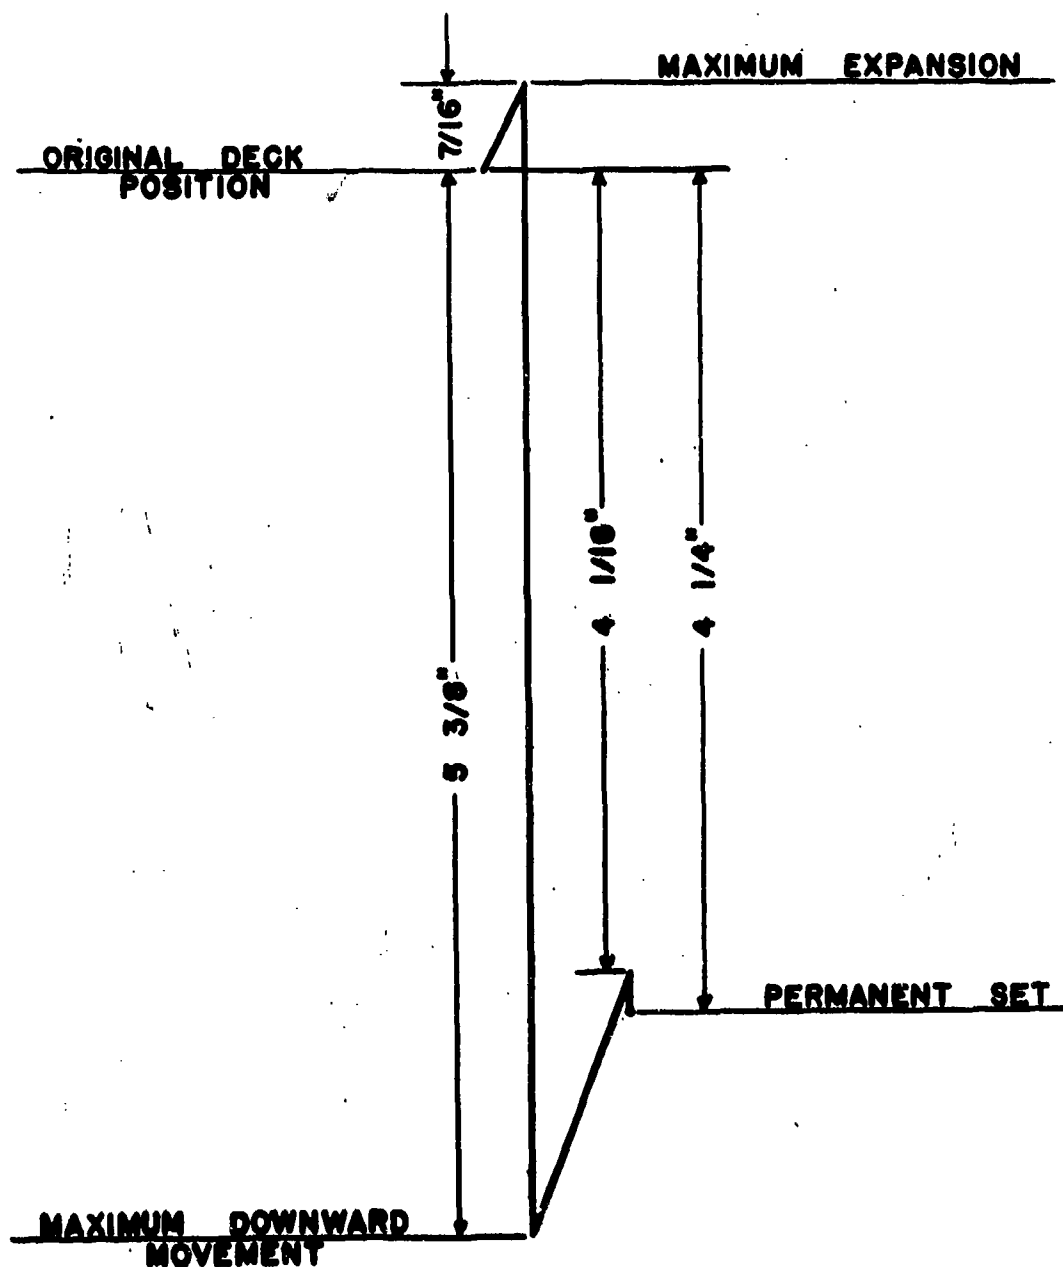
U.S.S. INDEPENDENCE, TEST ABLE, PLOT OF MAIN DECK
MOVEMENT. SCRATCH GAGE LOCATION, 2ND. DECK
FRAME 120 STD. 16'-7" OFF CENTER LINE.

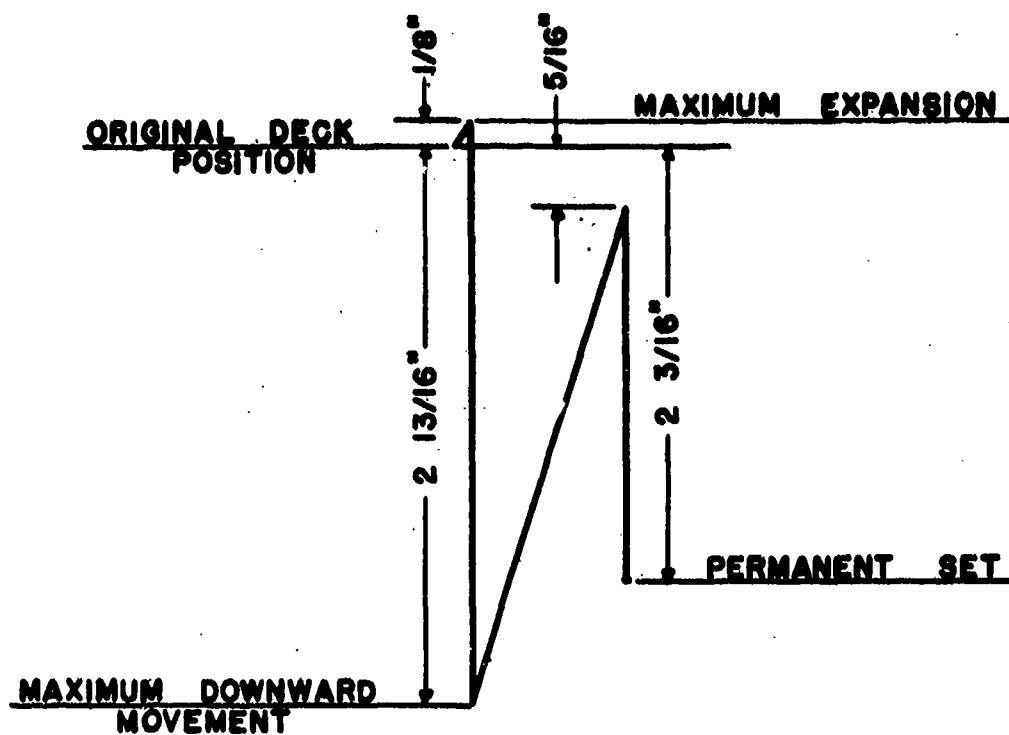
U.S.S. INDEPENDENCE, TEST ABLE, PLOT OF MAIN DECK
MOVEMENT. SCRATCH GAGE LOCATION, 2 ND. DECK
FRAME 121 CENTER LINE.

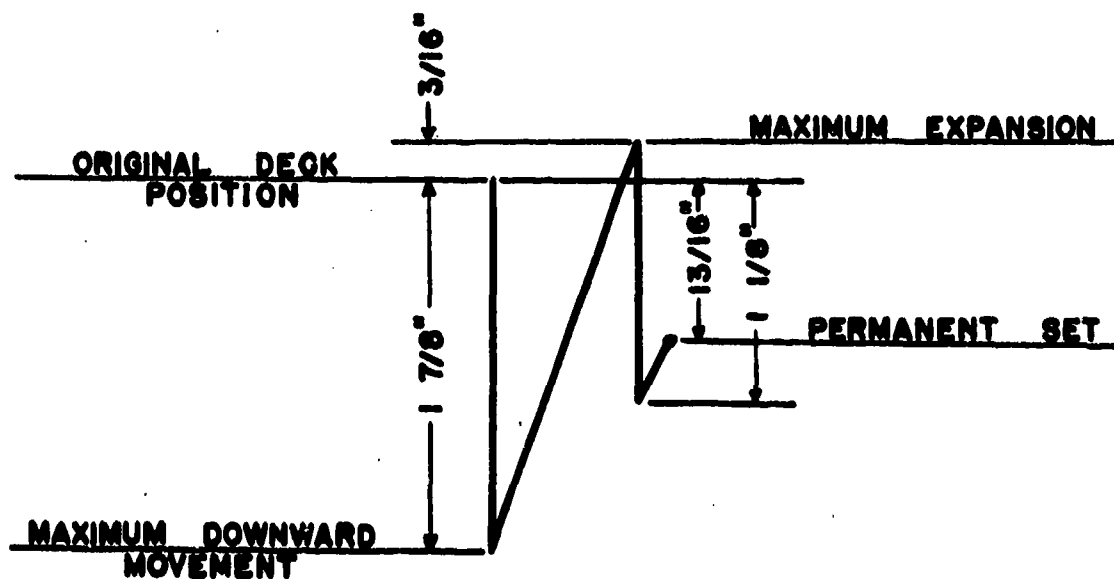
U.S.S. INDEPENDENCE, TEST ABLE, PLOT OF MAIN DECK
MOVEMENT. SCRATCH GAGE LOCATION, 2ND. DECK
FRAME 124 CENTER LINE.
